Horn Ring Problem

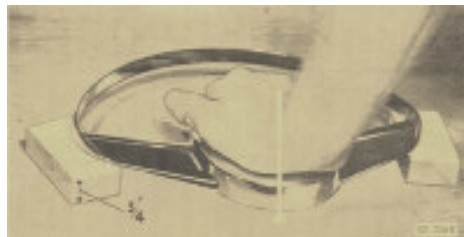
On all 1951-54 Kaisers (except 54-55 Manhattan) in many cases the horn ring contacts the steering wheel before activating the horn. This is caused by the horn ring being flat instead of having a slight bend. The center should be slightly bent downward. To correct this problem Factory Service Bulletin No. 246 explains the fix.

Imparting a slight bend set to Horn Ring

*Place a piece of 3/4 inch thick wood at both outer edges of the horn ring and press down on the center just enough to impart a slight bend. This bends the outer edges upward and allows clearance between the ring and the steering wheel. **Take care not to over bend the ring sufficient to break it.***
